ANALYTICAL AND PRACTICAL STUDY OF SOME FIGHTING ARTIFACTS FROM YEMEN

by Mohamed M. Megahed

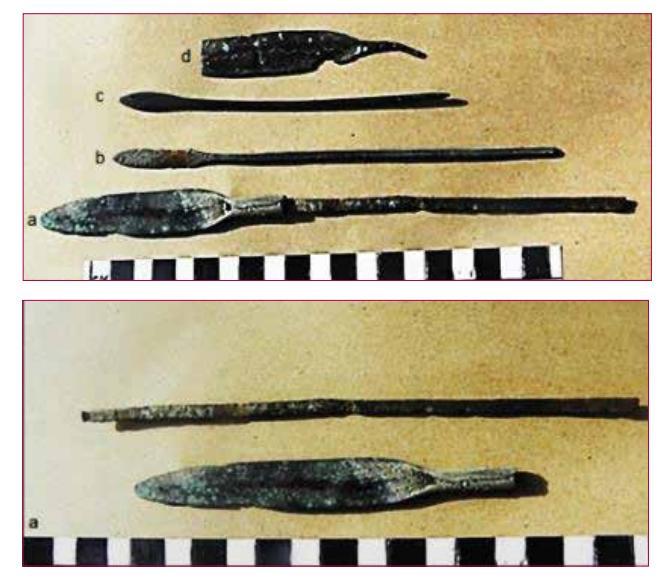
- The spear a, is separated into two parts, the completely length of the spread is 26 cm (the length of hand 16.5 cm with thickness 0.5 cm, the length of the head is 11.5 cm, the maximum width of the head is 1.7 cm and the minimum 0.5 cm). It suffered from deterioration factors, covered with a thick layer of black corrosion products mixed with soil dirt's (Figs. no1a, 2).
- The spear b, the completely length of it is 19 cm (the

Figs. 1, 2 - Shows the spears before the treatment.

length of hand 15 cm, the length of the head is 4 cm, the maximum width of the head is 0.7 cm). It suffered from deterioration factors, covered with a thick layer of black corrosion products mixed with soil dirt's (Figs. no.1b).

- The spear c, the completely length of the spread is 14.5 cm (the length of hand 12 cm with thickness 0.5 cm, the length of the head is 2.5 cm). It suffered from deterioration factors, covered with a thick layer of black corrosion products mixed with soil dirt's (Figs. no.1 c).
- Ahead of spear d, the completely length of the spread is 9.5 cm (the length of hand 2.5 cm, the length of the head is 7 cm, the maximum width of the head is 1.5 cm), it has a geometric decorations in the middle. It suffered from deterioration factors and covered with a layer of black corrosion products (Figs. no.1d).

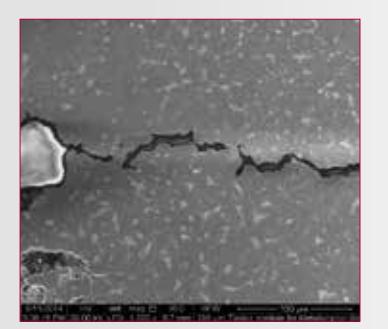
Fig. 7 - SEM ex., for the spear a, shows the stress corrosion and cracks(1000x).

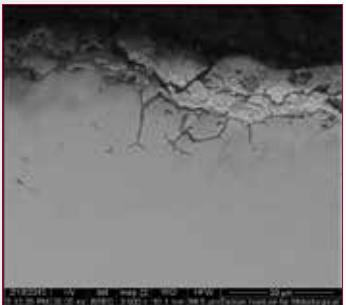
Fig. 8 - SEM ex., for the spear b, shows cracks and distorting of the edge of the alloy (3000x).

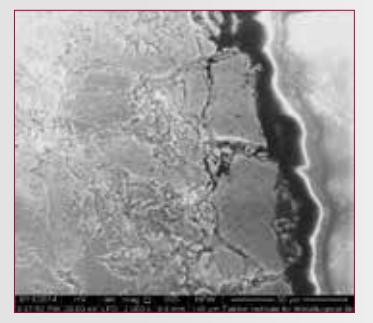
Fig. 9 - SEM ex., for the spear c, shows the cracks and distorting the surface (2000x).

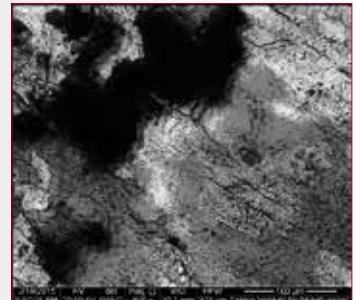
Fig. 10 - SEM ex., for the spear d, shows the pitting corrosion and distorting the edge(800x).

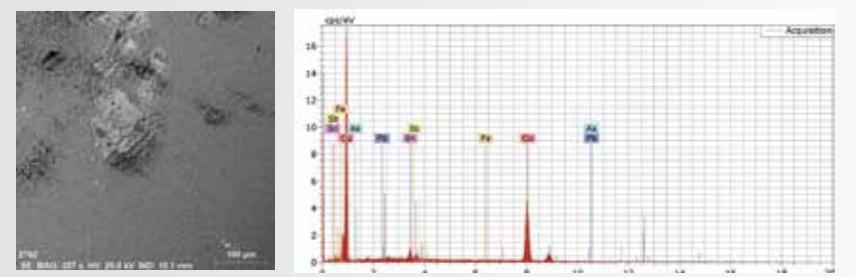
Fig. 11 - Shows SEM&EDS ex., of the spear a, the photo shows consist of the alloy, tin appears in a light color, pitting corrosion and SEM&EDS Scan shows the elemental composition of the spear a.

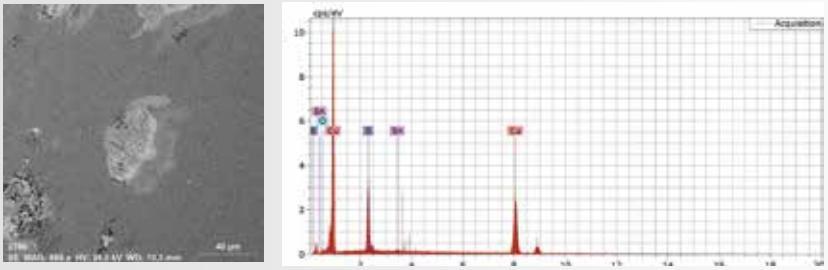
Fig. 12 - Shows SEM&EDS ex., of the spear b, the photo shows the spots of sulfate appears in a white color and SEM&EDS Scan shows the elemental composition of the spear b.

The presence of Brochantite (CuSO4.3Cu (OH) 2), Anhydrite (CaSO4) and Digenite (Cu9S5) in corrosion products of the spear b (Fig. 16 & Table 2) reflected the chemical composition of the spear b, which has a high amount of Sulphide reaches to 15.92% as it shown in SEM&EDS analysis results (Fig. 12&Table 1), it indicated that there is a strong relation between the chemical composition of the alloy and the kind of corrosion products. The sulphide corrosion has, however been produced while the selected objects has been in the care of Dhamar museum, Yemen. Many authors have studied the form of sulphide formation on bronze which occur in museums and the reaction between copper and hydrogen sulphide [22-28], in most cases it is described as resulting in an even layer. Sulphide may be come from the industrial pollution, an unfortunate choice of showcase materials or the presence of Carbon Sulphide which, as pointed out recently, is quite wide spread and in comparatively large quantities, finally Sulphide may become from the first step of extraction copper from its ores.

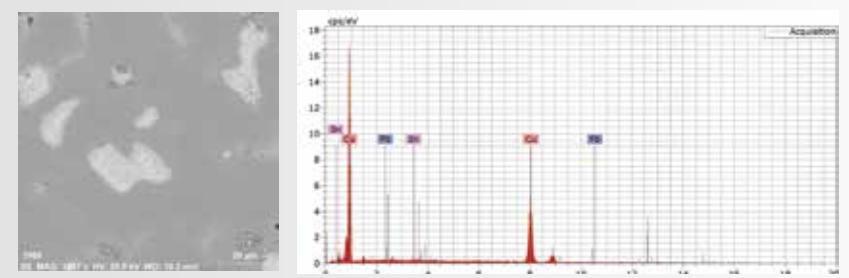
Fig. 13 - Shows SEM&EDS ex., of the spear c, the photo shows consist of the alloy, pitting corrosion dispersed in the alloy and SEM&EDS Scan shows the elemental composition of the spear c.

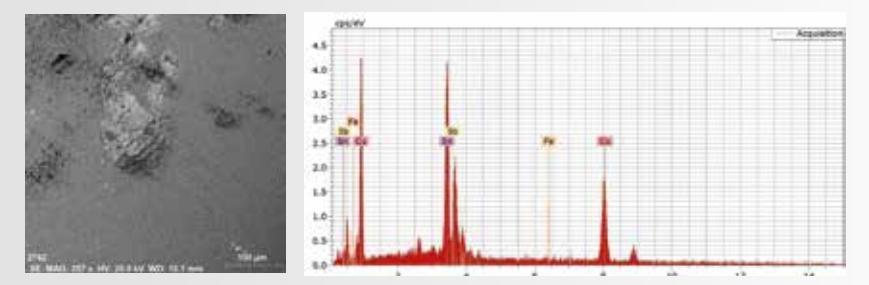
Fig. 14 - Shows SEM&EDS ex., of the spear d, the photo shows the consist of the alloy, tin appears in a white color, pitting corrosion and SEM&EDS Scan shows the elemental composition of the spear d.

The presence of Tin Oxide in (SEM-EDX, Fig. no. 14 &XRD, Fig. no. 18) reflected the chemical composition of the spear d. and indicated that there is a strong relation between the chemical composition of the alloy and the kind of corrosion products. The existence of Sodium Oxide Na2O in corrosion products analysis results of spear a, and Sodium Nitrate (NaNO3) in spear c (Figs. 15, 17 & Table no. 2) indicated that the burial environment was rich with sodium salts. Also the existence of Hematite Fe2O3 in a minor amounts in corrosion products of the spear a, (Fig.15 and Table 2), may be as a result of migration of Iron corrosion from adjacent iron objects to the selected bronze spears in the burial environment or from the buried environment itself as it is very rich with Iron compounds, this indicates the strong interaction between soil components and corrosion products.

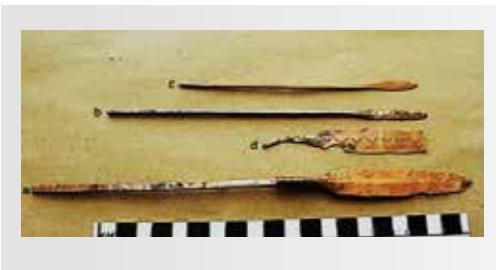
Fig. 19 - Shows the spears after treatment and conservation.

- Soaking the spears completely in dilute solution of Calgon [Sodium Hexametaphosphate Na(PO₃₁n], that was changed many times assisted by gentle mechanical cleaning with silk brush from time to time to dissolve the corrosion layers and the calcareous sediments. This step succeeded in removing the calcareous sediments, cupric oxide and cuprous oxide.
- After that the spears were soaked in water and washed by a tooth brush to dislodge residue from crevices.

- Repeated washing in hot deionized water baths with altering heating and cooling to ensure flushing capillaries to remove any chemical residues.
- Drying in repeated baths of ether and ethanol followed by drying in hot saw dust and mopped dry with soft, clean cloth.
- Finally the spears were isolated with paraloid B-72 dissolved in Acetone 3% by using a brush (Figs. no.19, 20).

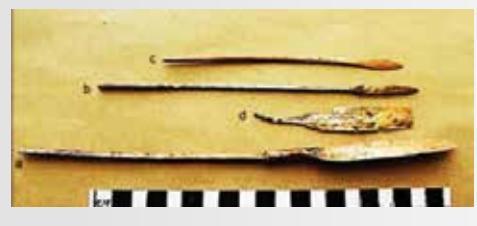
Fig. 20 - Shows the second side of the spears after treatment and conservation.
