DEVELOPMENT OF EARTHQUAKE COUNTERMEASURES ON HERITAGE BUILDINGS IN JAPAN

by Eisuke Nishikawa

This paper shows an overview of recent development of earthquake countermeasures on Japanese heritage buildings, which are mostly wooden buildings, and the paper also introduces its past history in order to provide the background.

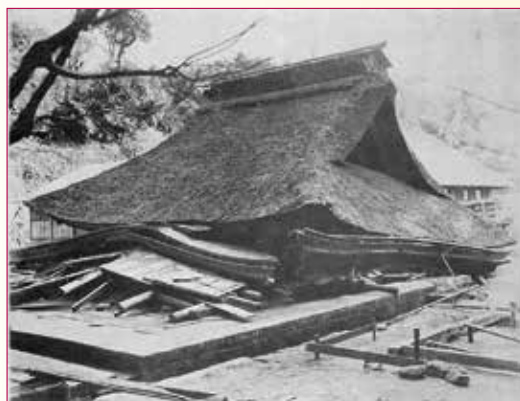
Fig. 1 - Collapse of Shariden of Enkaku-ji. (Source: Special report on the survey and restoration of Enkakuji Shariden: National Treasure).

Earthquake damage in the modern times can be known more concretely by referring to some written reports and photos. In 1911, the Great Kanto Earthquake hit the Kanto area, which includes Tokyo and nearby area. *Shariden* (reliquary hall) of *Enkaku-ji* (Buddhist temple) collapsed, and the roof landed with keeping its shape (Fig.1). A lot of heritage buildings in nearby temples and shrines including *Kencho-ji* (Buddhist temple) and *Tsurugaoka-hachimangu* (Shinto shrine) were also severely damaged.

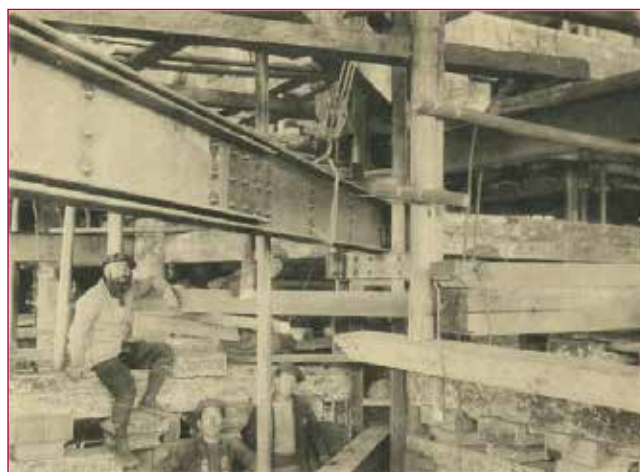
Fig. 2 - Reinforcement of Nandaimon of Todai-ji (Source: Report on the restoration of Todaiji Nandaimon: National Treasure).

Nandaimon (great south gate) of the same temple was repaired in 1929. Then H-shaped steels were installed in some beams with these beams split in half (Fig.2).

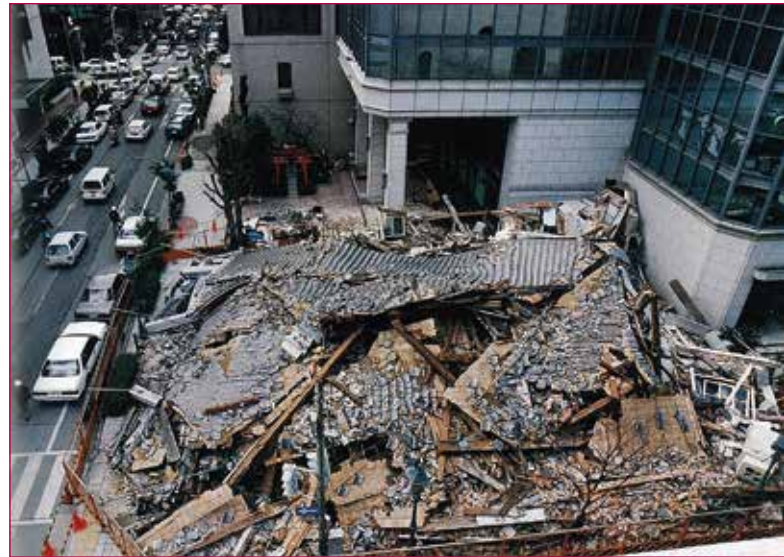
Fig. 3 - Collapse of the building No. 15 of the former settlement in Kobe (Source: Report on the restoration of No.15 building in the former settlement of Kobe: Important Cultural Property).

The No.15 building in the former foreign settlement of Kobe, which was used as a restaurant at that time, totally collapsed (Fig.3). Because the earthquake occurred in early morning, there were no deaths from the collapse. But if it had occurred in daytime, some users would have lost their lives. Necessity of earthquake countermeasures on heritage buildings was strongly re-recognized. This building was repaired in about 3 years, and a base isolation device was installed.

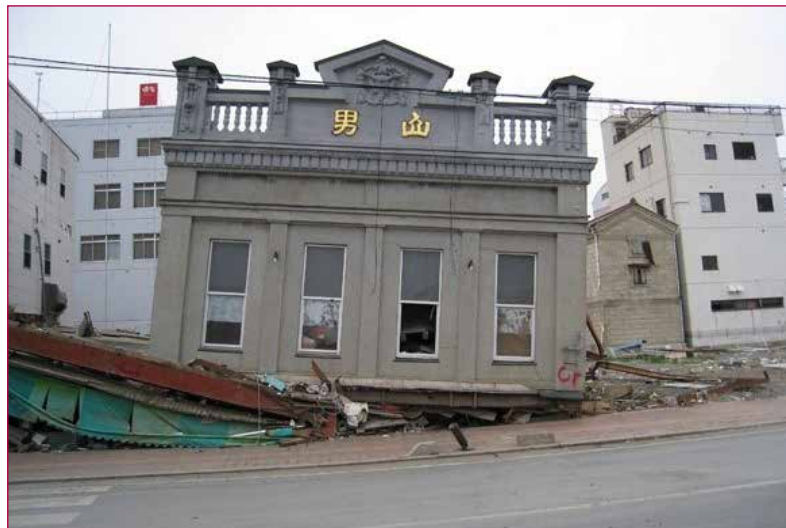
Fig. 4 - Collapse of the shop building of Otokoyama (Source: staff of the Agency for Cultural Affairs).

The shop building of *Otokoyama* (Japanese Sake brewery), which had three stories before the earthquake, lost its lower 2 stories due to a crash of a fishing boat swept away by the tsunami (Fig.4). This building is remaining in a state applied emergency treatment.

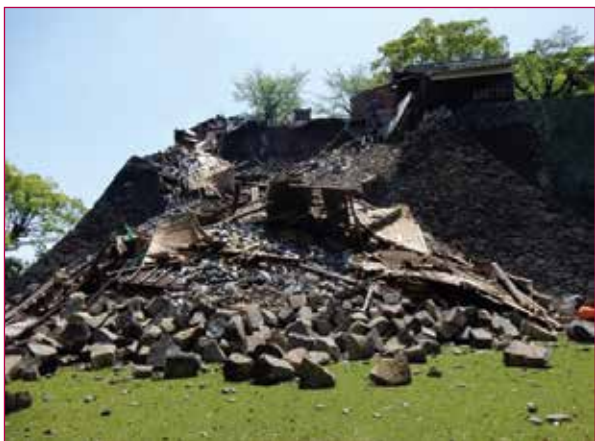
Fig. 5 - Collapse of Kumamoto castle (Source: staff of the Agency for Cultural Affairs).

Kumamoto castle, which is an important symbol for local people, was severely damaged. A lot of stone bases crumbled, and some buildings on these felt down and collapsed (Fig.5).

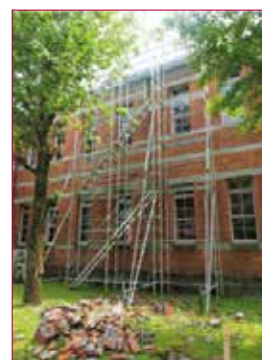
Fig. 6 - Dropping chimney of Kumamoto University building (Source: staff of the Agency for Cultural Affairs)

Some heritage brick buildings in Kumamoto University were also severely damaged, a lot of cracks were generated on walls, and a lot of chimneys fell down (Fig.6).

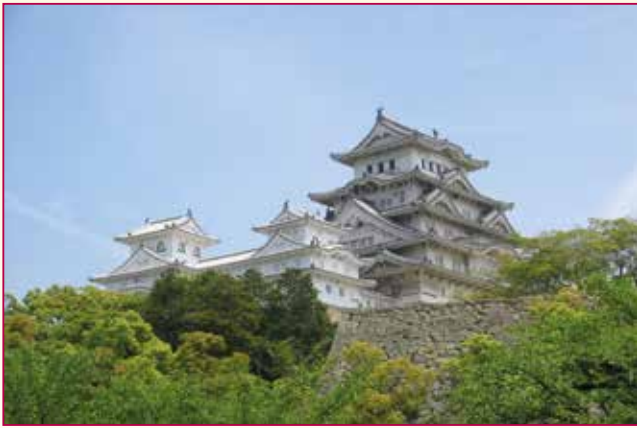
Fig. 7 - Himeji castle (Source: Shuji Kato, a conservation architect).

For example, the earthquake countermeasure of *Daitenshu* (great keep) of *Himeji* castle was implemented in the restoration project from 2009 to 2014 (Fig.7). Experiments of some structural elements, including earthen wall (Fig.8), were conducted, and a vibration observation on site was also performed. By using these results, its behavior during an earthquake was simulated by a time history response analysis with a three-dimensional model (Fig. 9). Then it was clarified that some columns and floors can be damaged severely in a big earthquake. Based on the result, the keep was reinforced with minimum intervention: attaching hardware only on the danger part of columns and floors.

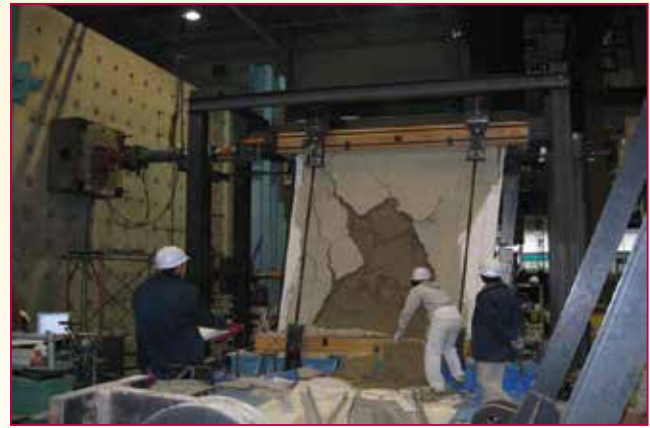
Fig. 8 - Experiments of earthen wall of Himeji castle (Source: Yoshiaki Tomi-naga, a structural engineer).

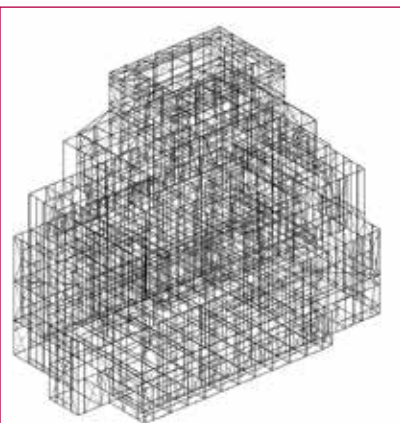
Fig. 9 - Analytical model of Himeji castle (Source: Tateishi structural engineering office).

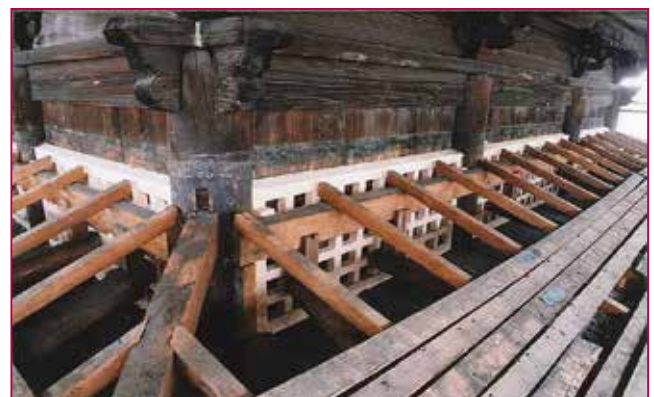
Fig. 10 - Reinforcement of *Knanondo* of *Eiho-ji* (Source: Masahiro Kato, a conservation architect).

Kannon) in *Eiho-ji* (Buddhist temple) was reinforced in the roof repair project from 2009 to 2012. Wooden lattice panels were installed in a space between its roof and ceiling (Fig.10), and additional beams were attached on the bottom of columns under its floor. These reinforcing materials have high deformability, which traditional wooden buildings also have, so the reinforcement matches the building structurally. In addition, all reinforcement was added out of sight almost without any change of original components, so original design and components were totally preserved. Furthermore, it can be restored to the original state by removing the additions if necessary in the future.
