ANALYTICAL AND PRACTICAL STUDY OF SOME FIGHTING ARTIFACTS FROM YEMEN

by Mohamed M. Megahed

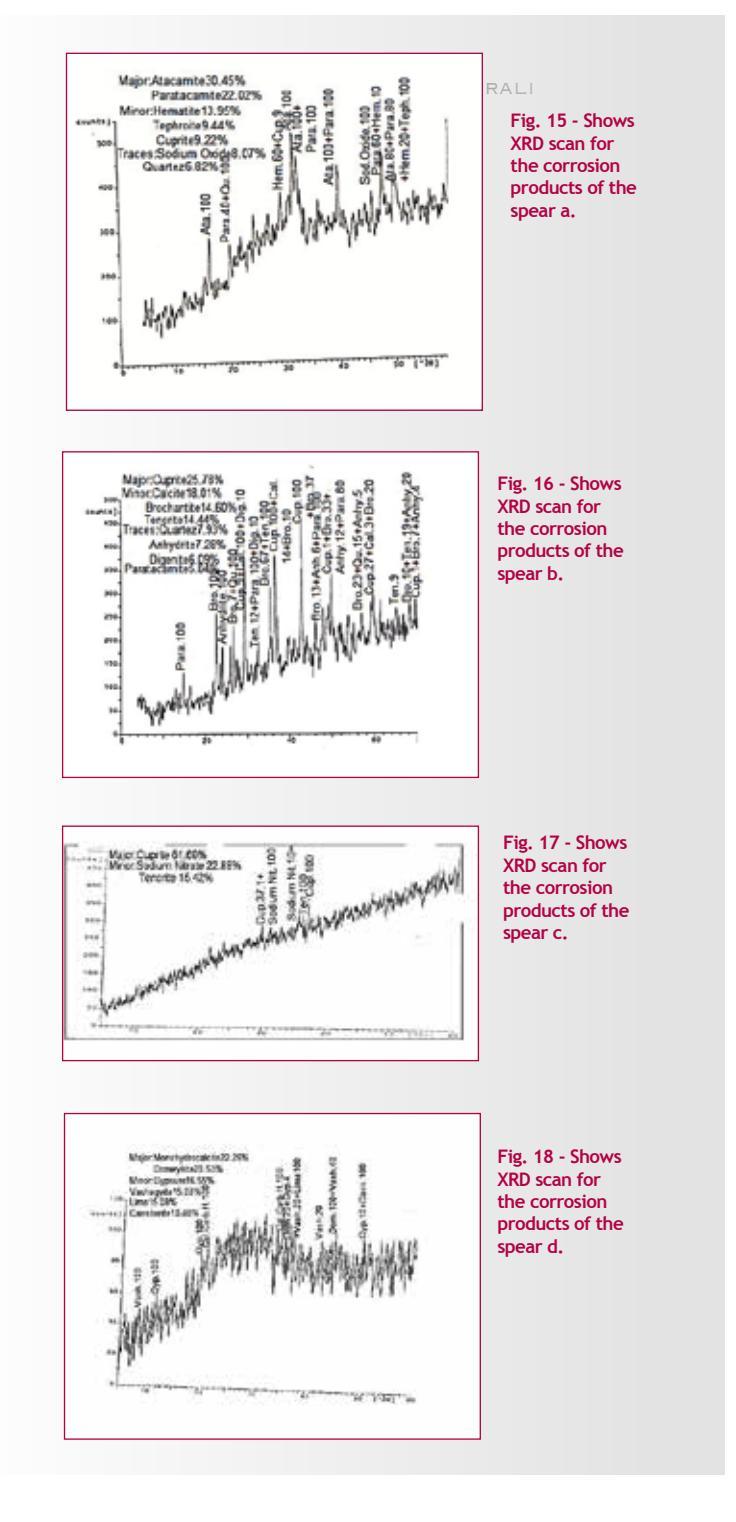
Fig. 12 - Shows SEM&EDS ex., of the spear b, the photo shows the spots of sulfate appears in a white color and SEM&EDS Scan shows the elemental composition of the spear b.

The presence of Brochantite (CuSO4.3Cu (OH) 2), Anhydrite (CaSO4) and Digenite (Cu9S5) in corrosion products of the spear b (Fig. 16 & Table 2) reflected the chemical composition of the spear b, which has a high amount of Sulphide reaches to 15.92% as it shown in SEM&EDS analysis results (Fig. 12&Table 1), it indicated that there is a strong relation between the chemical composition of the alloy and the kind of corrosion products. The sulphide corrosion has, however been produced while the selected objects has been in the care of Dhamar museum, Yemen. Many authors have studied the form of sulphide formation on bronze which occur in museums and the reaction between copper and hydrogen sulphide [22-28], in most cases it is described as resulting in an even layer. Sulphide may be come from the industrial pollution, an unfortunate choice of showcase materials or the presence of Carbon Sulphide which, as pointed out recently, is quite wide spread and in comparatively large quantities, finally Sulphide may become from the first step of extraction copper from its ores.
